Re: Marion Town House Existing Conditions Assessment

EXISTING CONDITIONS ASSESSMENT

JANUARY 14, 2011

Marion Town House

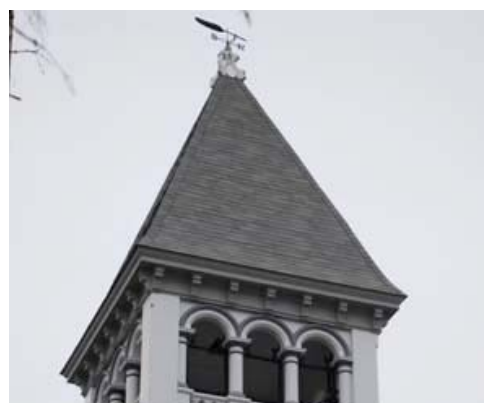
2/X-1.5 - Tower roof

The asphalt shingles are grey single-tab strip shingles, 3'-0" long. They are in generally in good condition, most appear less than 15 years old. The tower roof (photo 2) seems to be newer than the rest perhaps within the last five years.

Regular semi-annual inspections are required for good long term roof maintenance. A regular fall and spring inspection would be a minimal first step.

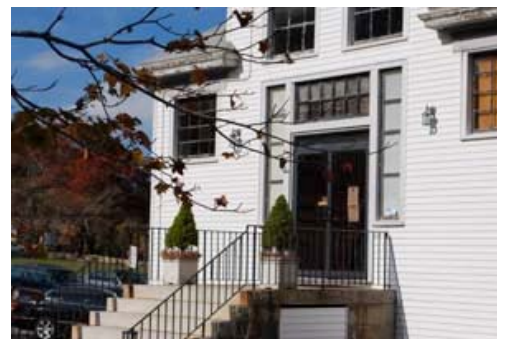
10/XL-1.1 - "Assembly" hall south door

The basement door can be use as a guide for any new replacement doors. In Photo 10 the contrast between the original opening with its glazed sidelights and transom and the new aluminum storefront door is quite noticeable.

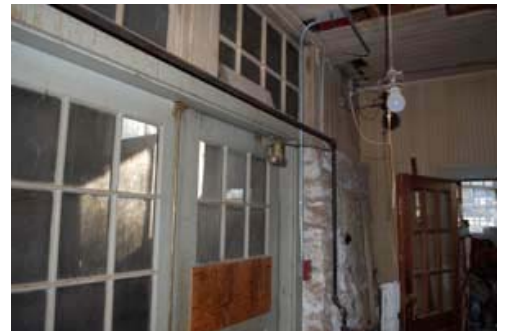
11/X-1.1 - Basement south door

Two exceptions are the bulkhead door on the west side of the building (photo 12) and an old original basement double door under the south entrance (photo 11). Both of these doors are in fair condition and need repainting.

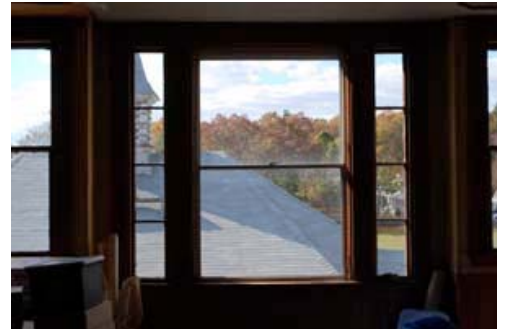
21/X-1.4 - Third floor dormer windows with replacement double-hung at center

There are a pair of double hung windows in the town administrators office (photo 22) and a single double hung on the third floor (photo 21) that have been replaced, but the rest of the windows appear to be original.

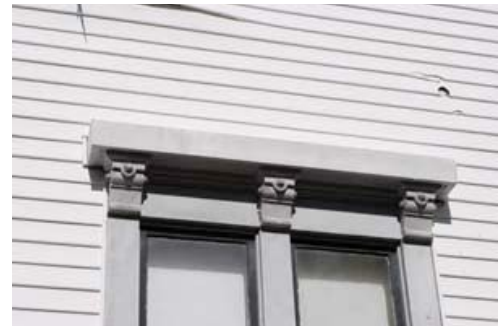
There are several areas where the vinyl has been damaged (photos 25 & 26) likely by wind-borne debris or falling ice and snow. The condition of the wall underneath is not clear. A common problem with vinyl siding on older buildings is moisture buildup underneath because of the absence of a suitable vapor barrier and the lack of proper insulation. Both of those systems should be carefully studied before any significant work is done on the siding. In the mean time the small holes should be patched with new vinyl siding.

25/X-1.2 - Minor damage to vinyl siding

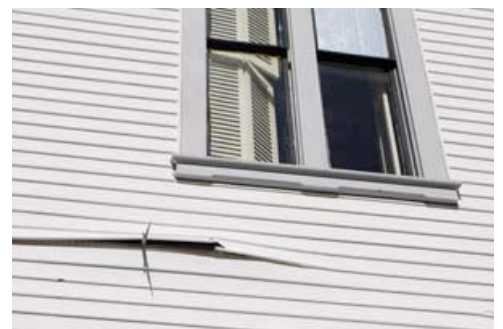
26/X-1.3 - Damage to vinyl siding

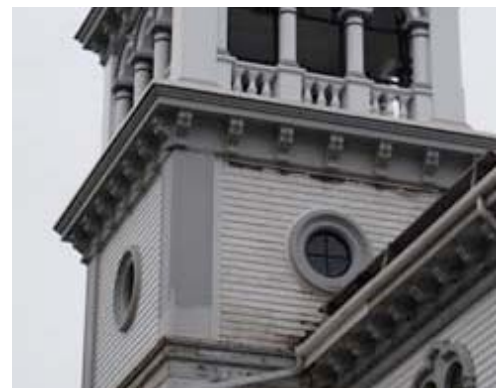
27/X-1.4 - Original clapboard at east wall of tower

Virtually all of the entire exterior of the building has been covered with vinyl siding. It is not clear whether some or all of the original siding remains in place or was removed as part of the re-siding work. There are a few areas in the dormers (photos 20 & 28) where some of the original shingle siding and decorative detail remain and are visible above the vinyl. Some of the vinyl siding has been removed on the tower (photo 27) and wood clapboard siding is visible in that location.

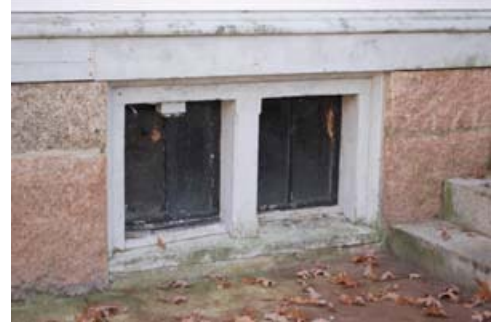
29/X-1.1 - Granite foundation

The foundation is in very good condition (see the structural assessment which follows) with no signs of significant movement.

In select areas where water has infiltrated the structure, the mortar is damaged or missing entirely.

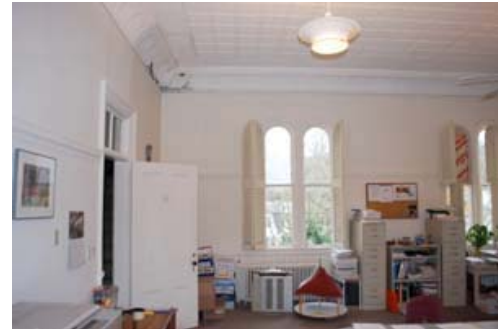
41/X-1.3 - Tin ceiling with minor damage at second floor

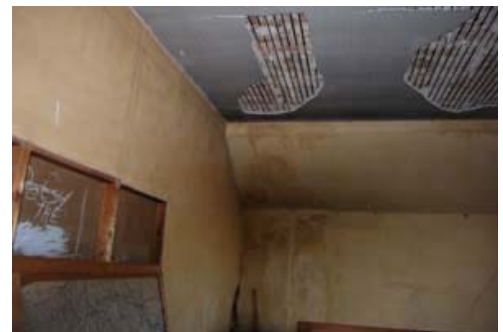
The plaster ceilings are all in need of minor patching and repair, none more than those on the third floor (photo 42).

42/X-1.4 - Plaster ceiling damage at third floor

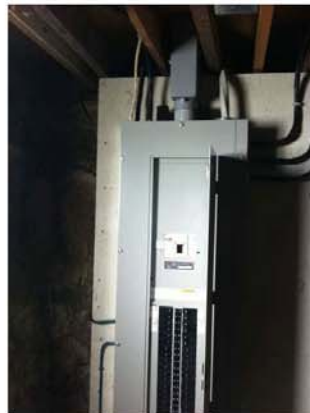
E1 New Electrical Service Panel

- The existing electrical service panels have been recently upgraded. The service rating is rated at 400 amp, 120/240 volt, 1Ø, 3 wire. The equipment is manufactured by Eaton, and is in good condition.

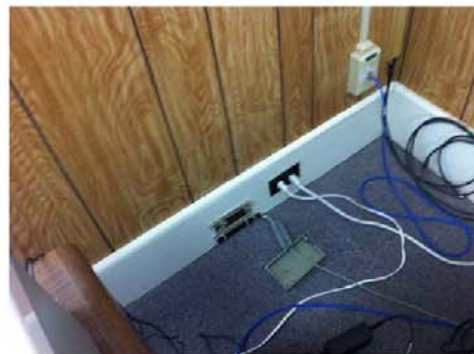
E10 Grounding Type Receptacle

- The existing receptacles are grounding-type. There have been receptacles added over the years to accommodate computers and other office equipment.
- The quantity of receptacles does not appear appropriate for the amount of equipment at each workstation. Extension cords are being used.

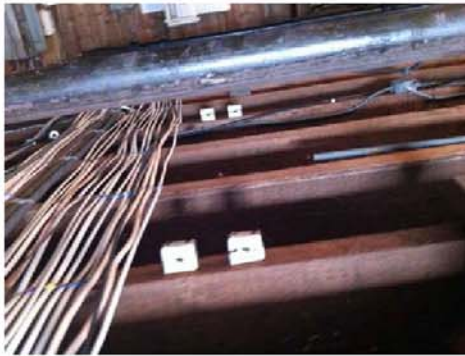
E11 Romex And Knob and Tube Wiring (Removed) at Basement

- There is a variety of wiring methods used for branch circuits. There is knob and tube wiring in the basement as well as the Third Floor. The knob and tube poses a hazard and should be removed. There is non-metallic sheathed cable present throughout (Romex). Romex is not allowed in assembly-use occupancy areas and where installed in dropped ceilings.

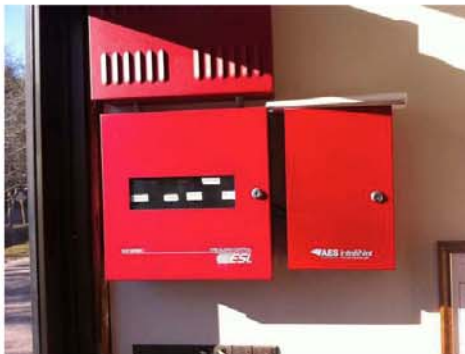
E12 Fire Alarm Control Panel

- The building is equipped with an automatic fire alarm system. The coverage appears minimal. The fire alarm control panel is manufactured by ESL and has five zones. There is an AES Alarm transmitter to the Fire Department Receiving Station.
- Toilet rooms do not have strobe lights installed.
- The existing system is not ADA compliant.
